StandardAero

TFE731-20R-1B

S/N: P111178

Engine Teardown Report

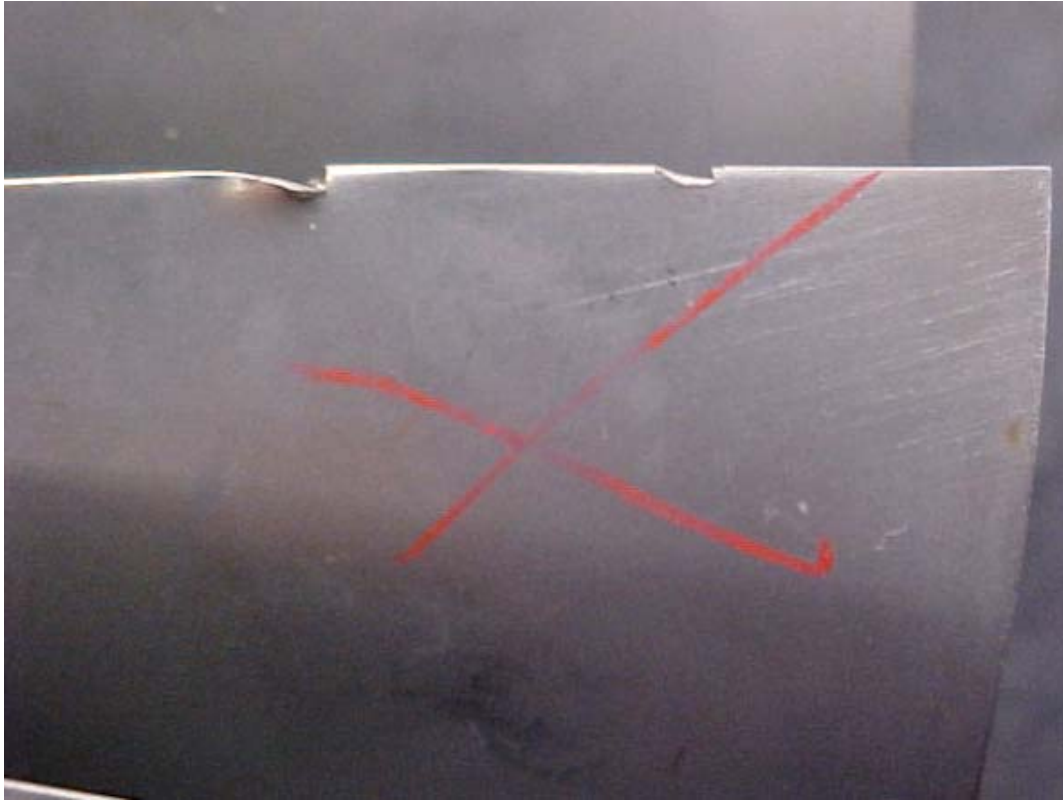
1ST STAGE LPC BLADE NICKED ON LEADING EDGE

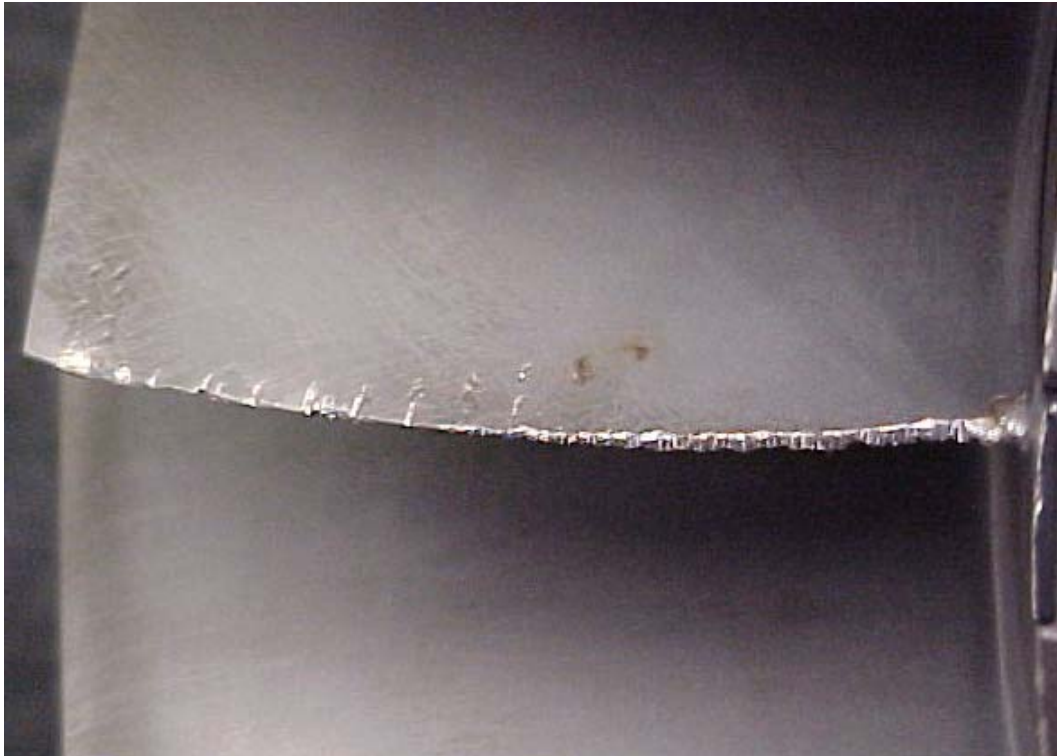
1ST STAGE LPC BLADE NICKED ON TRAILING EDGE

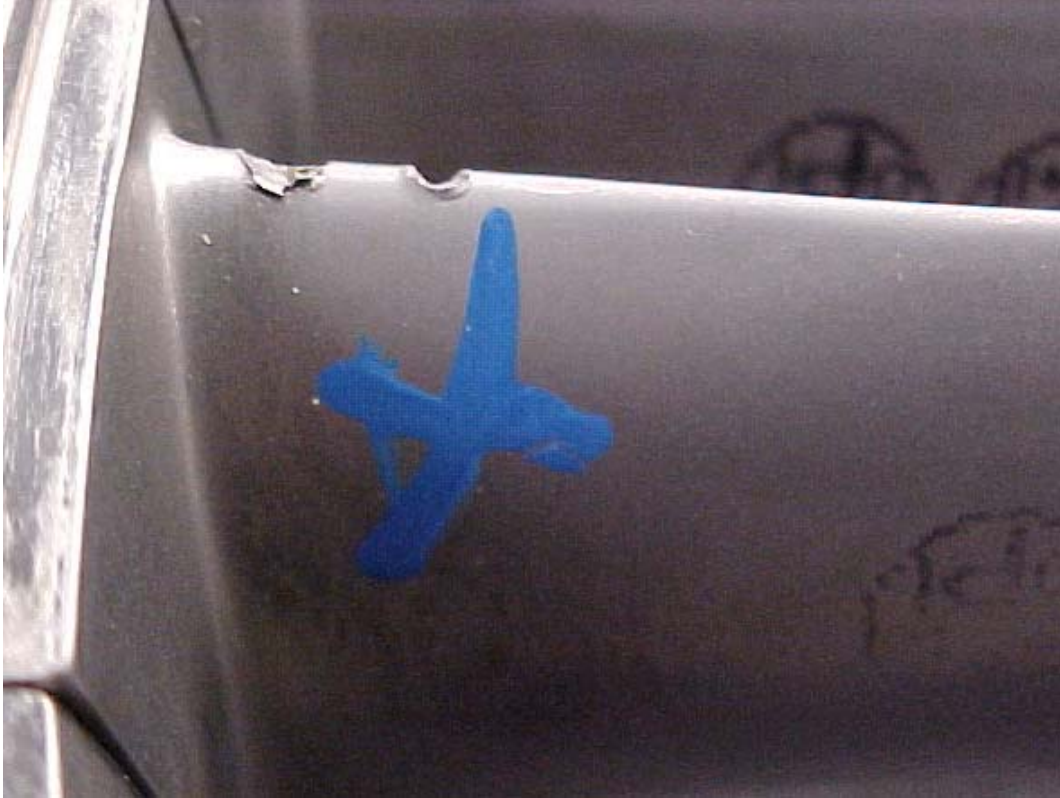
1ST STAGE LPC STATOR VANE NICKED ON LEADING EDGE

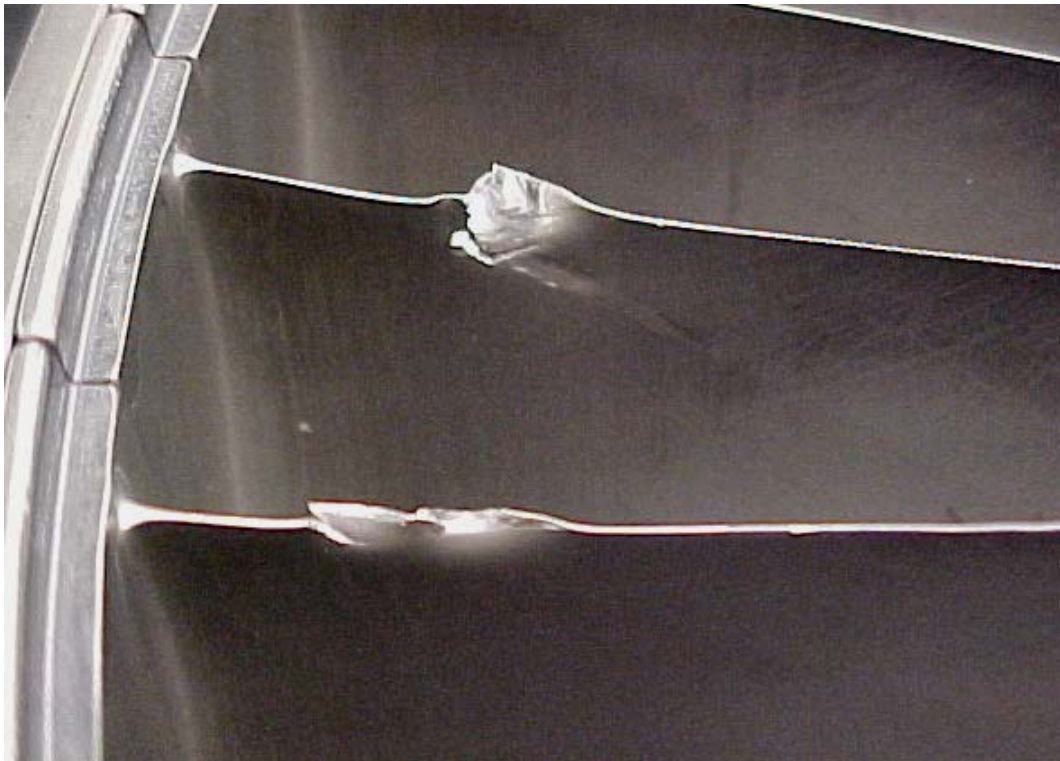
1ST STAGE LPC STATOR VANE NICKED ON TRAILING EDGE

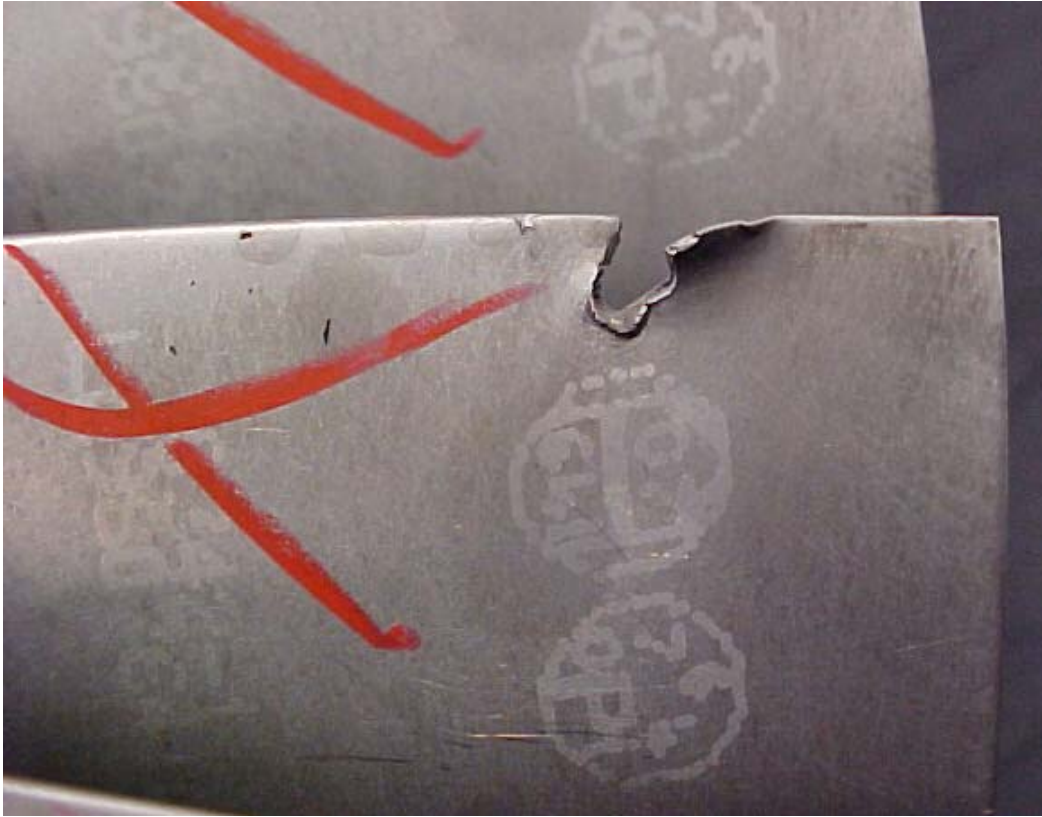
2ND STAGE LPC BLADE NICKED ON LEADING EDGE

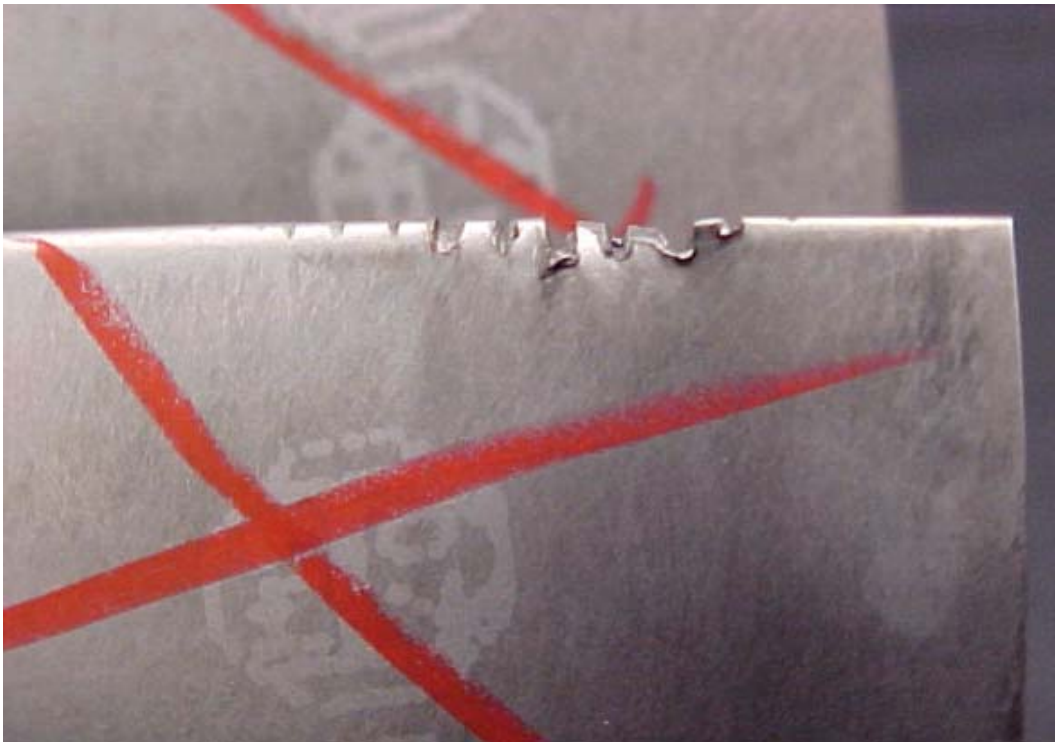
2ND STAGE LPC BLADE NICKED ON LEADING EDGE

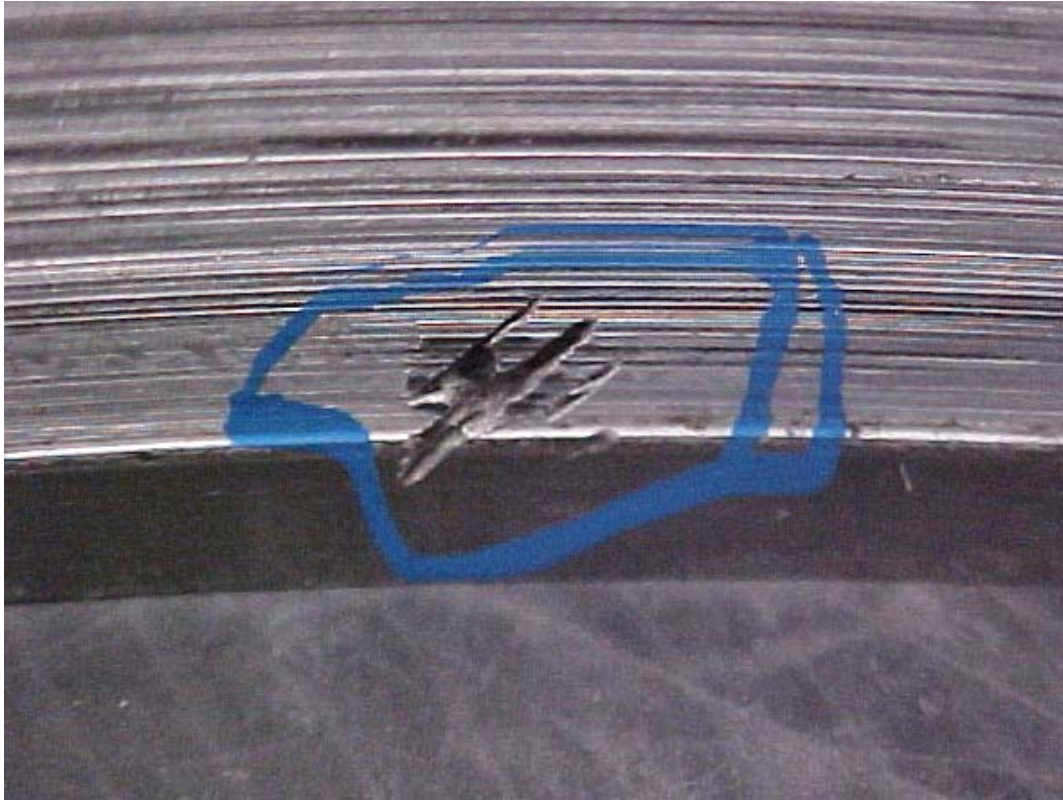
2ND STAGE LPC STATIONARY SHROUD NICKED ON INNER SURFACE

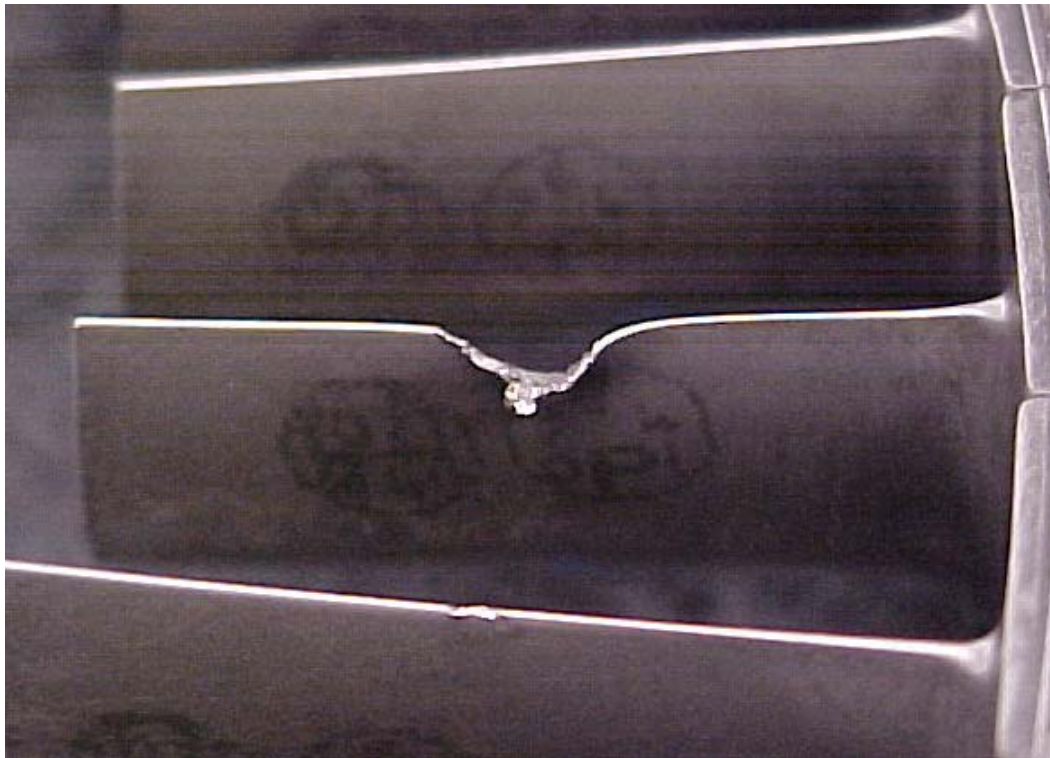
2ND STAGE LPC STATOR VANE NICKED ON LEADING EDGE

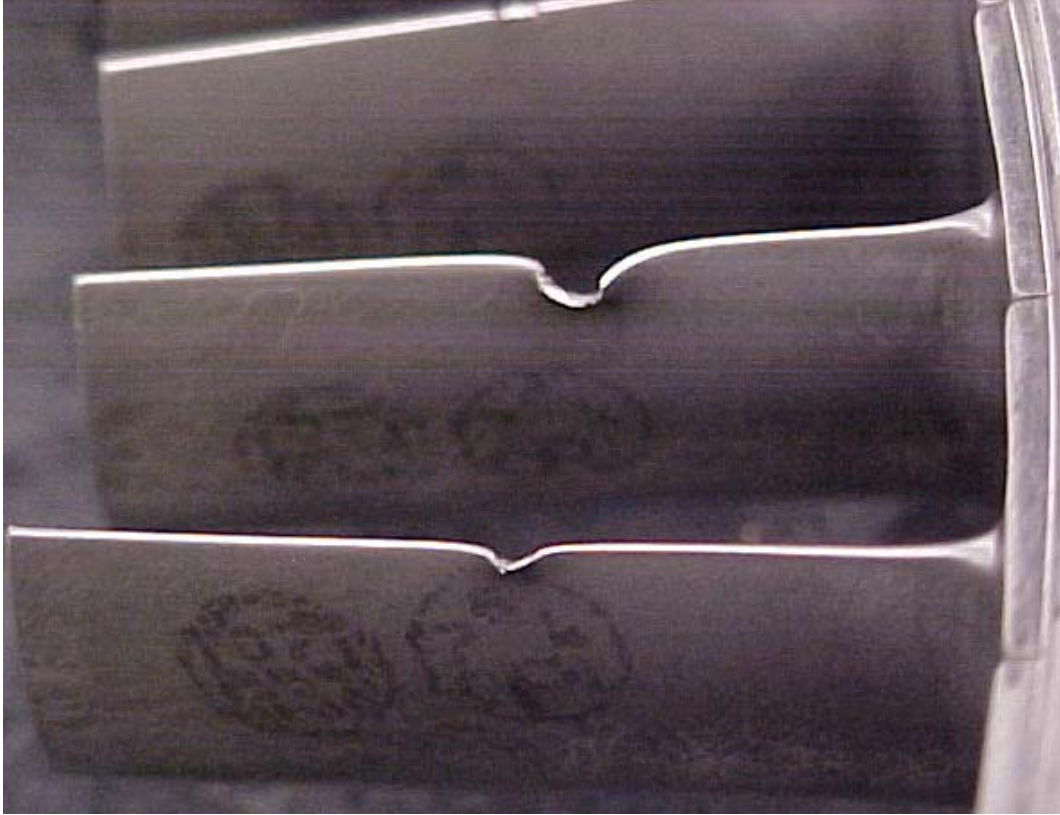
2ND STAGE LPC STATOR VANE NICKED ON LEADING EDGE

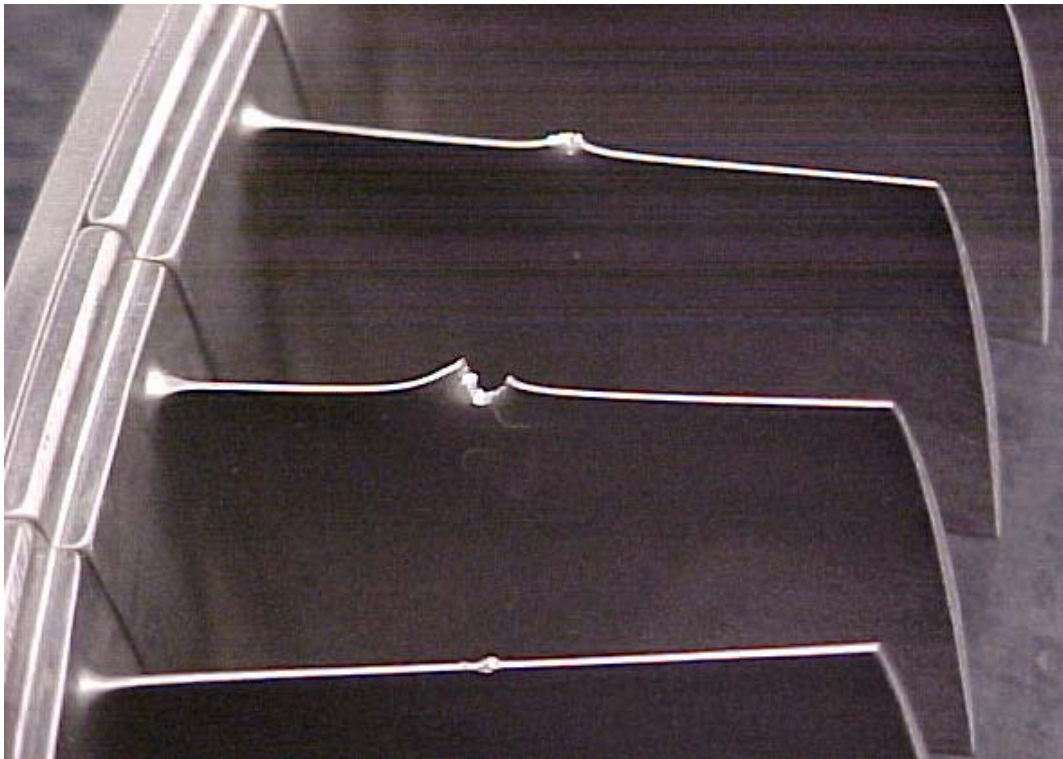
2ND STAGE LPC STATOR VANE NICKED ON TRAILING EDGE

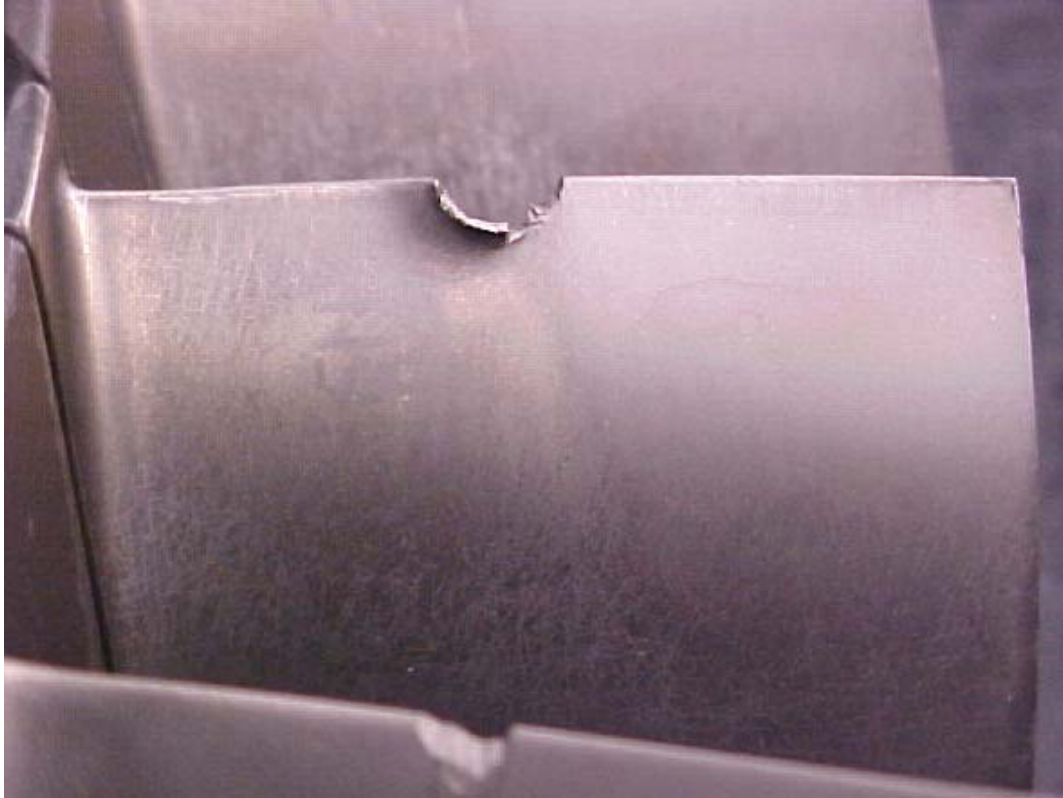
3RD STAGE LPC BLADE NICKED ON LEADING EDGE

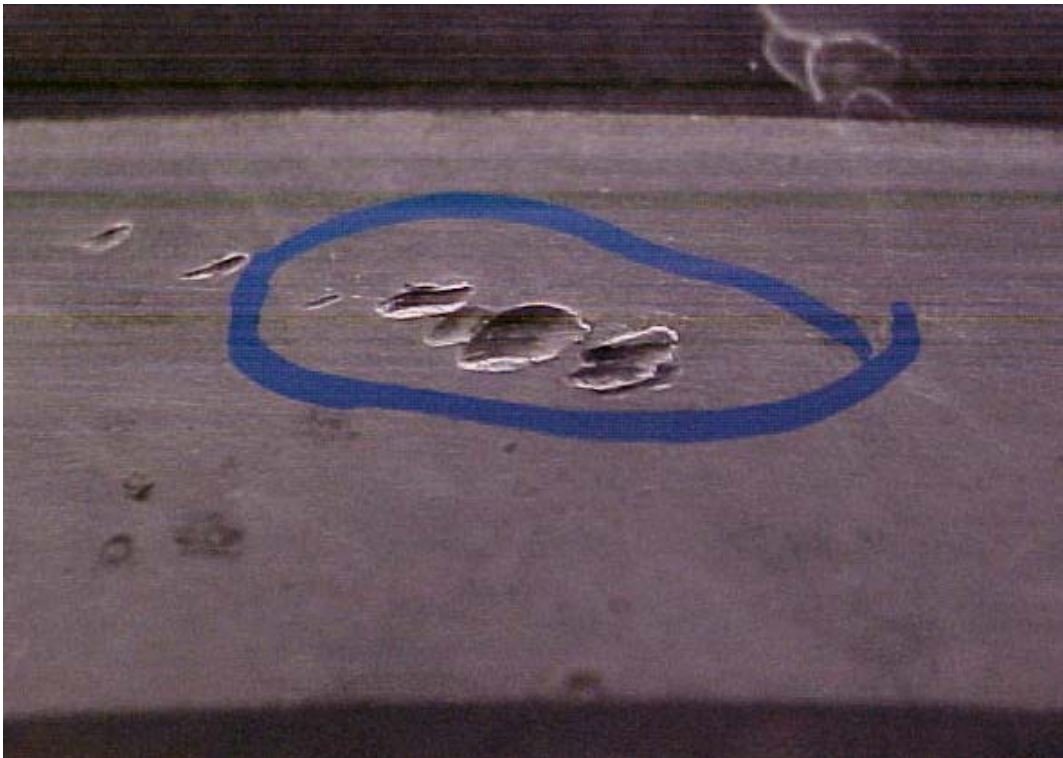
3RD STAGE LPC STATIONARY SHROUD NICKED ON INNER SURFACE

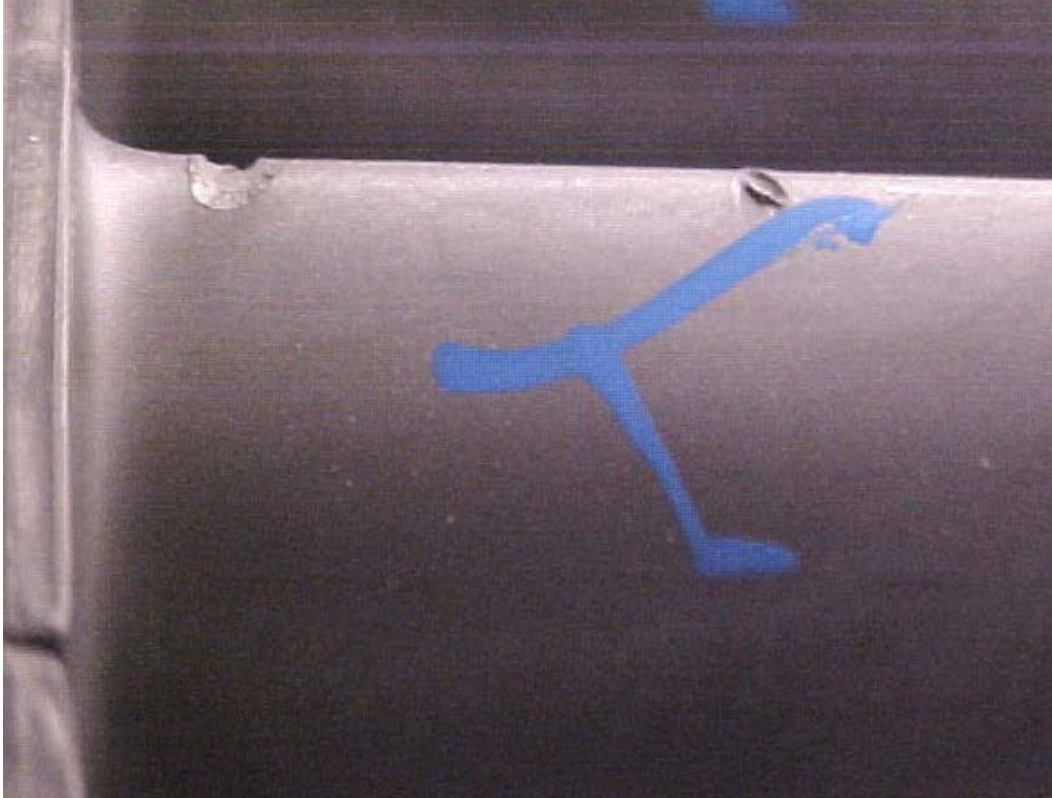
45	3060348-4	3 rd Stage LPC Stator Vanes	Damaged	Replace
42	3060344-1	4 th Stage LPC Blades	Damaged	Replace
1	3060361-4	4 th Stage LPC Stator Assy	Vanes are nicked	Replace
1	3060358-3	Interstage Diffuser	Struts are nicked on LE	Repair
1	3075639-2	#4 Carbon Seal Runner	Separated	Replace
1	3060316-4	HPC Impeller Shroud	Nicked	Replace

3RD STAGE LPC STATOR VANE NICKED ON LEADING EDGE

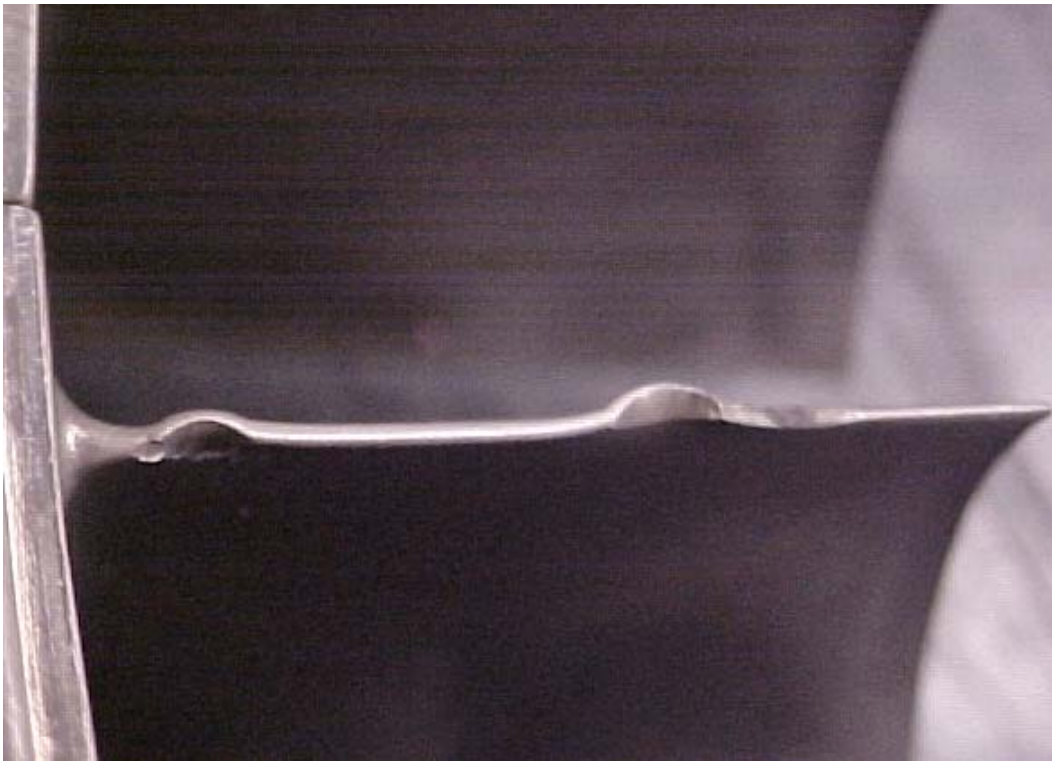
3RD STAGE LPC STATOR VANE NICKED ON TRAILING EDGE

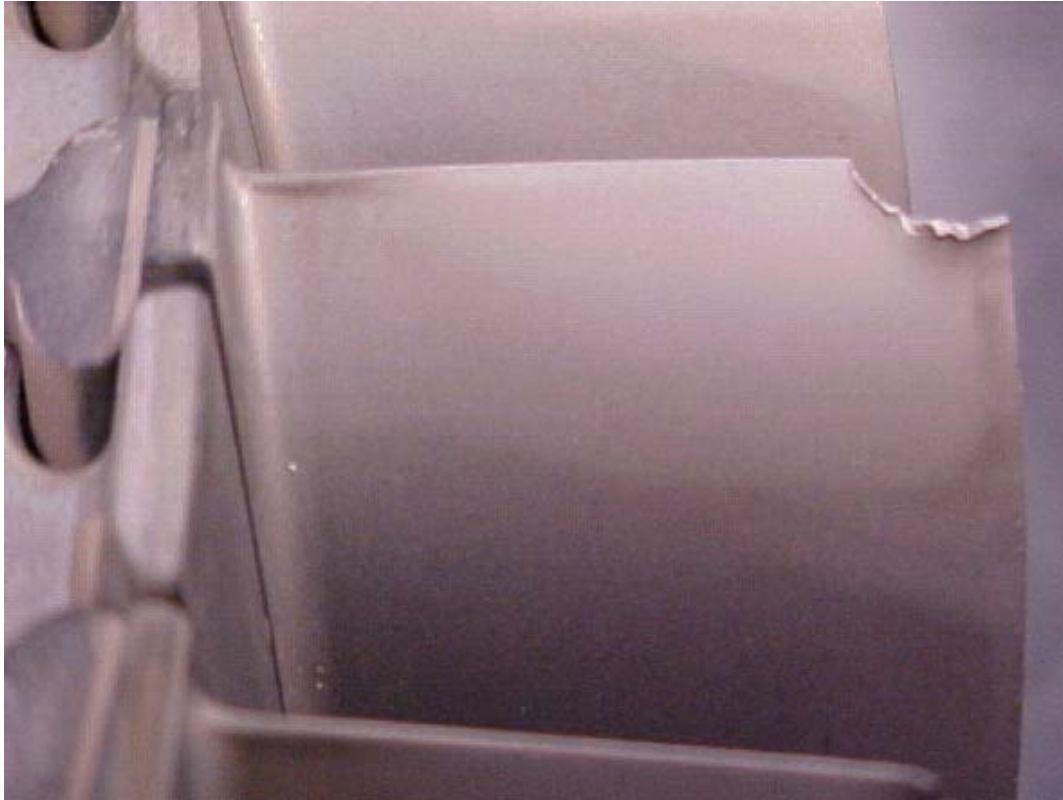
4TH STAGE LPC BLADE NICKED ON LEADING EDGE

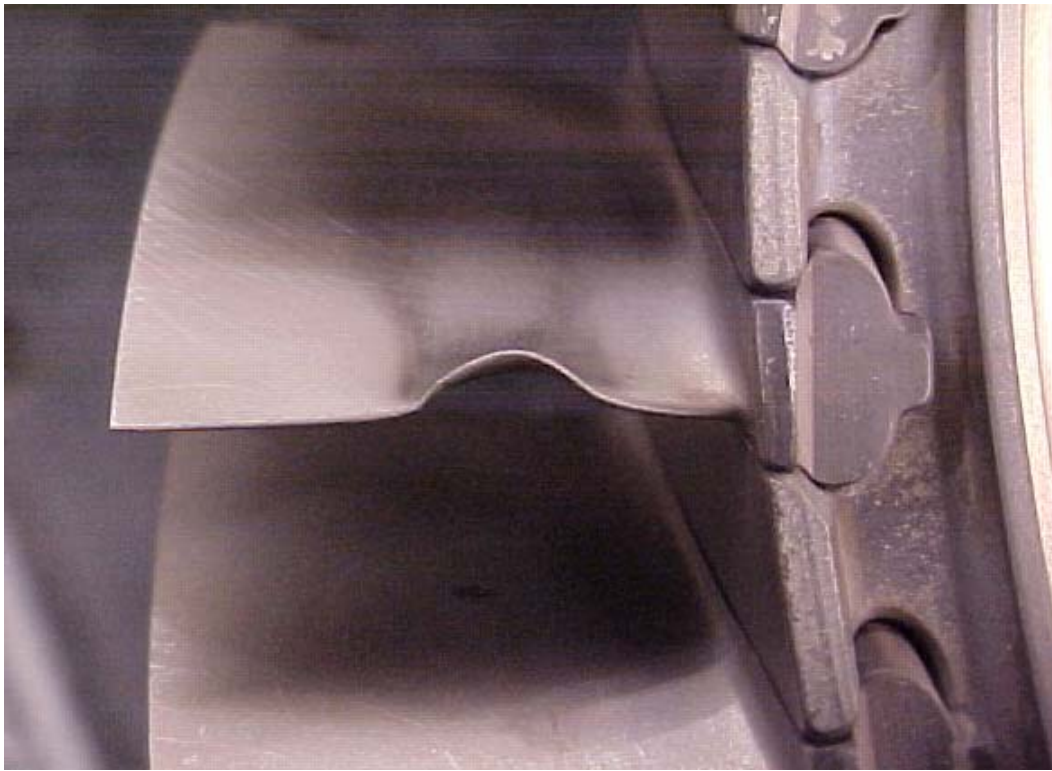
4TH STAGE LPC BLADE NICKED ON LEADING EDGE

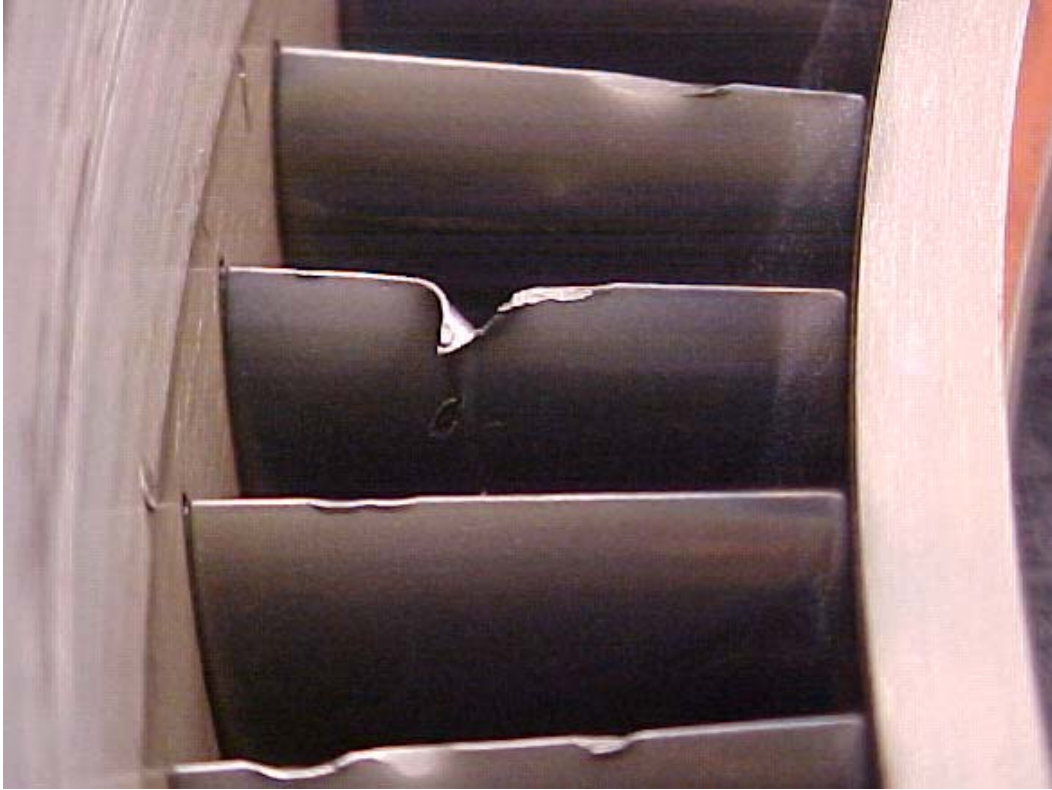
4TH STAGE LPC STATOR VANES NICKED ON LEADING EDGE

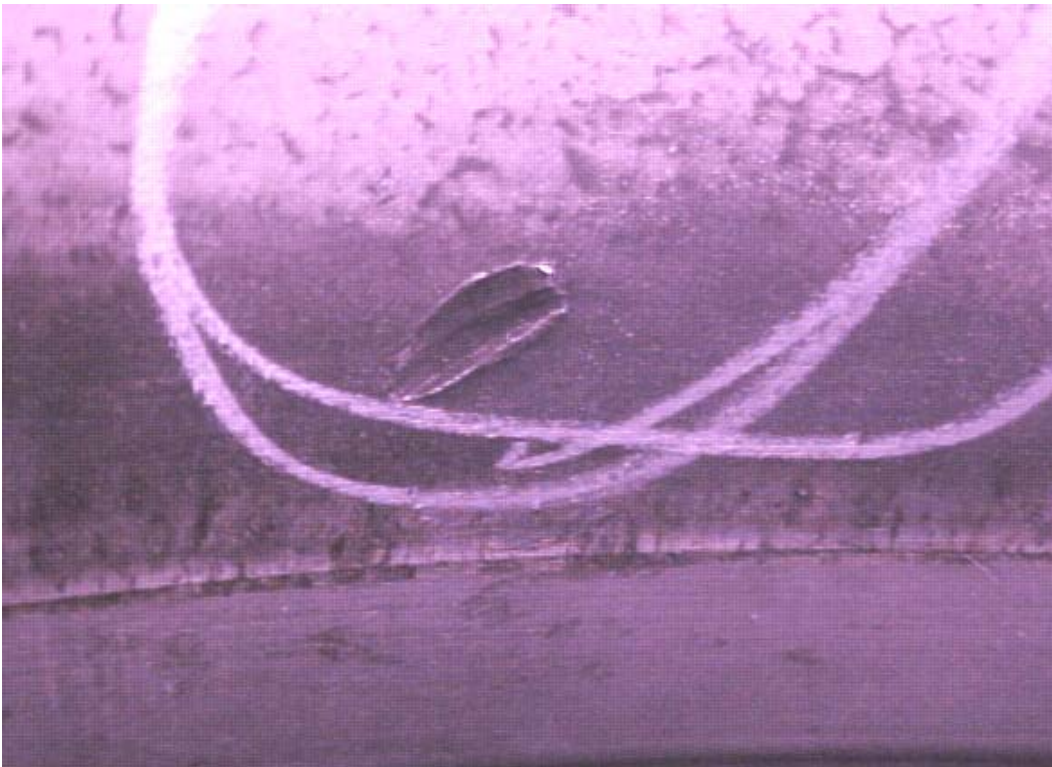
HPC IMPELLER SHROUD NICKED ON INNER SURFACE

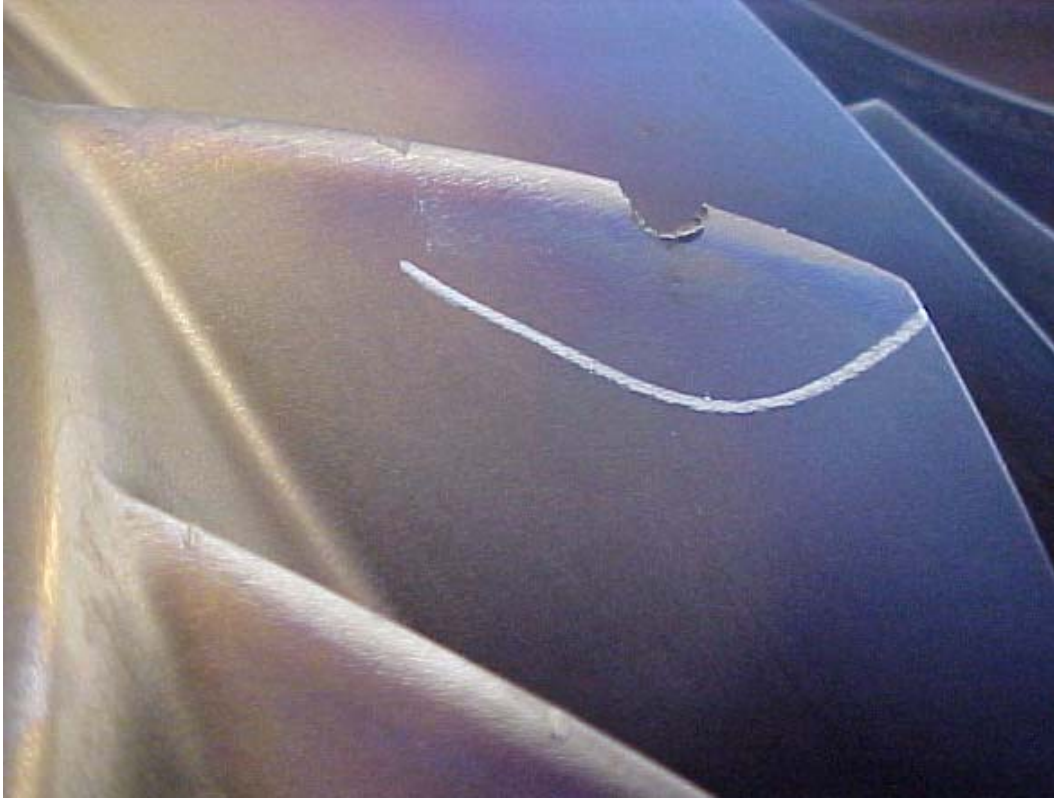
Qty.	Part Number	Description	Discrepancy	Disposition
1	3060371-1	HPC Impeller	Vanes are nicked on LE	Replace
1	3060318-8	HPC Diffuser	1 ea vane is nicked on LE	Replace
1	3060573-1	Outer Transition Liner	Comply with SN 72-5152	Replace
1	3060502-2	HPT Forward Coupler	PN and SN are unreadable	Repair
1	3060691-1	HPT Disc	Life limited	Replace
1	3060763-1	ITT Harness	Failed functional check	Replace
64	3060649-4	1 st Stage LPT Blade Retainers	Comply with SB 72-5204	Replace
2	3060695-2	1 st Stage LPT Shroud Segments	Honeycomb seal is damaged	Replace
2	3060665-1	1 st Stage LPT Retaining Ring Pins	Threads are damaged	Replace
1	3060666-7	1 st Stage LPT Stator Assy	3 ea loose rivets	Repair
52	3060649-5	2 nd Stage LPT Blade Retainers	Comply with SB 72-5204	Replace
52	3060608-2	2 nd Stage LPT Blades	Comply with SB 72-5140	Replace
1	3060685-2	2 nd Stage LPT Nozzle Retainer	Comply with SB 72-5165	Replace
9	3060654-3	2 nd Stage LPT Shroud Segments	Comply with SB 72-5165	Replace

HPC IMPELLER VANE NICKED ON LEADING EDGE

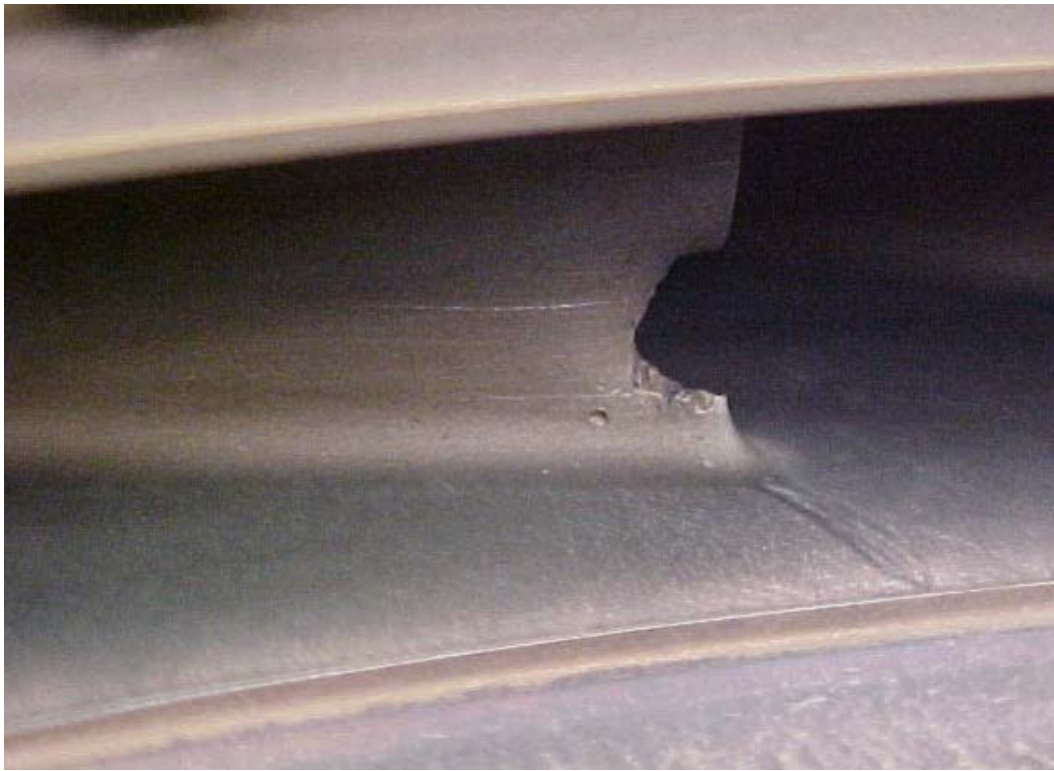
HPC DIFFUSER VANE NICKED ON LEADING EDGE
