StandardAero

TFE731-20R-1B

S/N: P111178

Engine Teardown Report

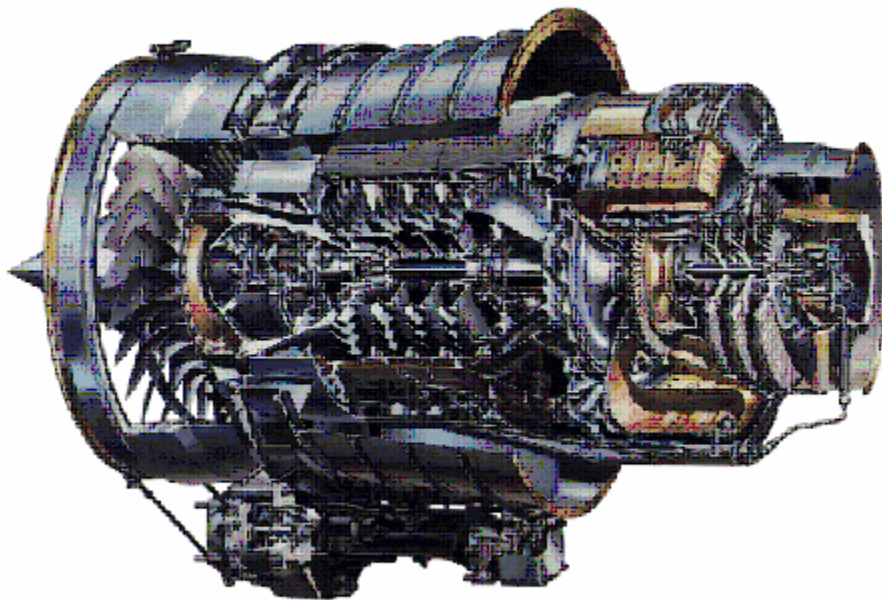
This engine is in house for a scheduled MPI event. During inspection, damage was found to the first stage LPC blades. Further disassembly and inspection revealed additional damage to the remainder of the LPC and HPC components.

There are sharp nicks on the majority of the LPC and HPC components; this type of damage is usually caused by metallic objects. Since no hardware seems to be missing from the engine, the object was most likely ingested from outside the engine.
